# Assessment of Subgrade Resilient Modulus for Identifying Causes of Pavement Failure: A Comparative Analysis

This study aims to investigate the parable causes of repetitive pavement failures of the Trimohini to Baromile road section of Rajshahi-Kushtia highway in Bangladesh. The comparison of different factors causing pavement failure between Trimohini to Baromile section and other non-repetitive failure type road (Dhaka Pabna Highway) was analyzed. Dynamic Cone Penetration (DCP) tests were carried out at six distinct locations from Trimohini to Baromile section and subgrade soil sample were collected for laboratory tests to obtain physical characteristics. The strength and physical properties at selected points of both highway sections was analyzed by examining data obtained from field tests and laboratory tests. The values of the subgrade resilient modulus of Rajshahi-Kushtia highway section were lower compared to other road sections of the Dhaka-Pabna highway. In the Trimohini-Baromile highway section, pavement failure is attributed to low subgrade resilience modulus and excessive moisture content. Conversely, the Pabna Bus Terminal-Madhupur Section maintains a higher subgrade

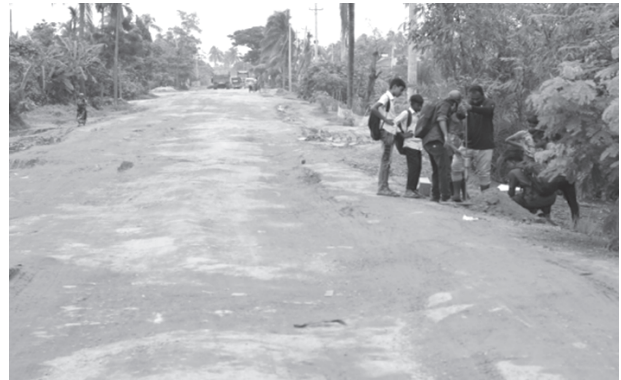
The pavement conditions varied across different sections. At Talbaria-Kadamtola, the surface lacked visible bituminous topping and showed depressions resembling wavy patterns under loaded vehicles. Ranakharia (Shown in Figure 2) exhibited severely poor conditions with no bituminous layer, exposing the base coarse and demonstrating inadequate drainage. Baromile-Chandgram section and Bahalbaria Bazar showed excessive surface rutting (Figures 3 and 4)

**Figure 2.** Pavement Condition at Ranakharia Mosque (23°57'47.1"N 89°04'11.2"E)

Pavement conditions along the Trimohini to Baromile section varied significantly. Locations like Talbaria-Kadamtola, Ranakharia, Baromile-Chandgram, and Bahalbaria Bazar exhibited severe issues such as rutting and surfacing deficiencies, which contribute to reduced road serviceability and increased maintenance costs. In comparison, the Madhupur to Pabna section displayed good pavement conditions with no visible distress signs, ensuring smoother travel and lower operational costs.

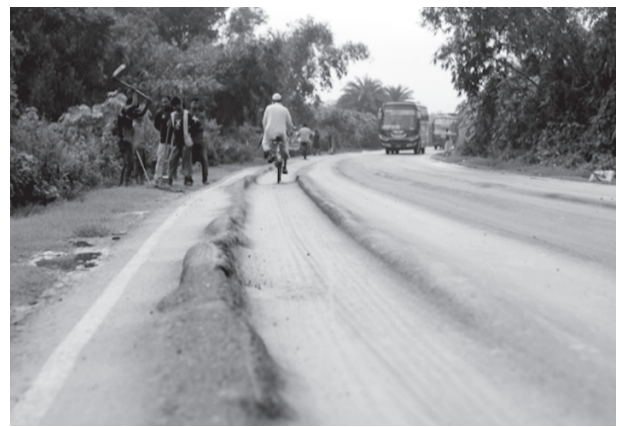
**Figure 3.** Rutting with high depth at Baromile (24°00'17.3"N 89°00'57.4"E)

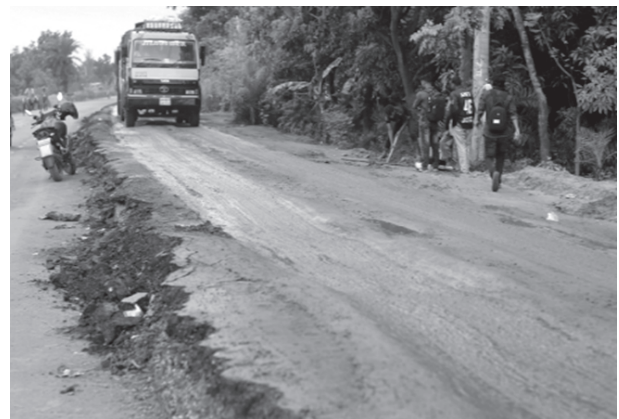
**Figure 4.** Rutting at Bahalbaria Bazar section (23°58'06.4"N 89°02'03.1"E)

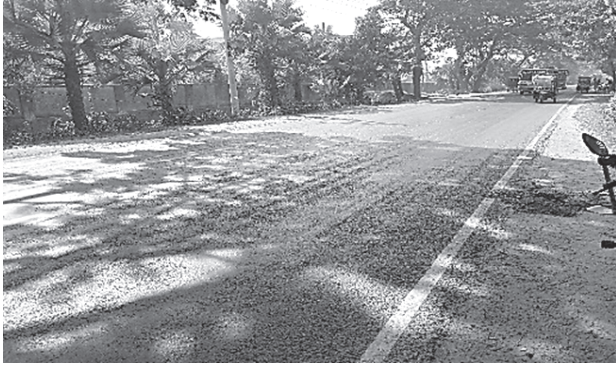
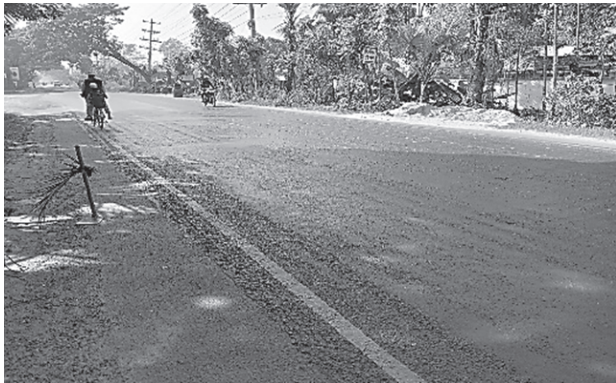
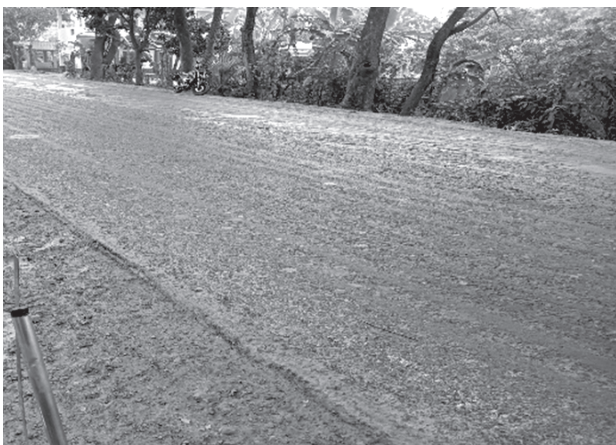
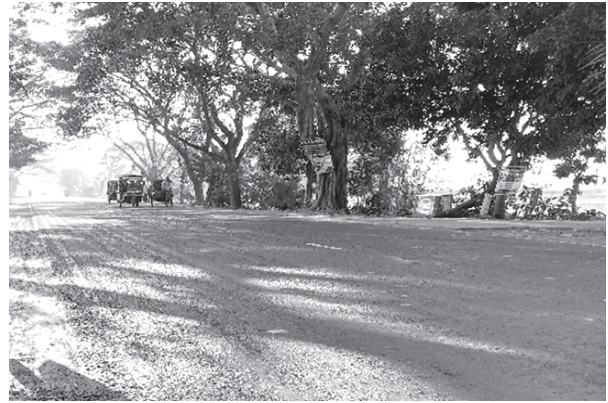
failure. Overall, the pavement section provided good serviceability and a comfortable riding quality due to its smooth surface which is shown in Figures 5, 6, 7 and 8 below.

**Figure 5.** DCP location at Rajapur-PUST road section (24°00'49.1"N 89°16'38.3"E)

**Figure 6.** DCP location at Jalalpur in front of Ratnodweep resort (24°01'14.6"N 89°17'26.9"E)

**Figure 7.** DCP location at Dhopaghata Uttorpara road section (24°01'47.9"N 89°19'10.7"E)

**Figure 8.** DCP Location of Madhupur Dokkhinpara road section (24°02'12.5"N 89°21'08.3"E)

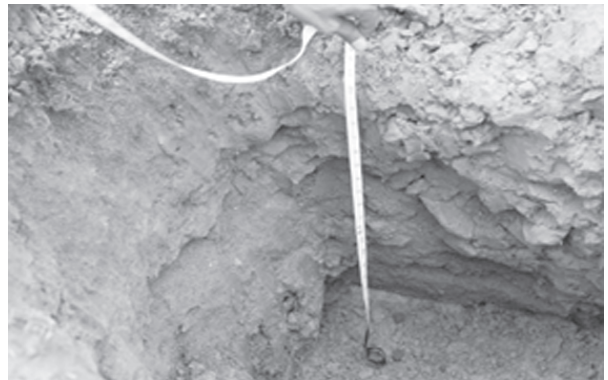
During pavement condition surveying, the pavement composition data (Figure 9) of different locations of Trimohini to Baromile road section were collected as shown in Table 1.

**Figure 9.** The Pavement composition is measured

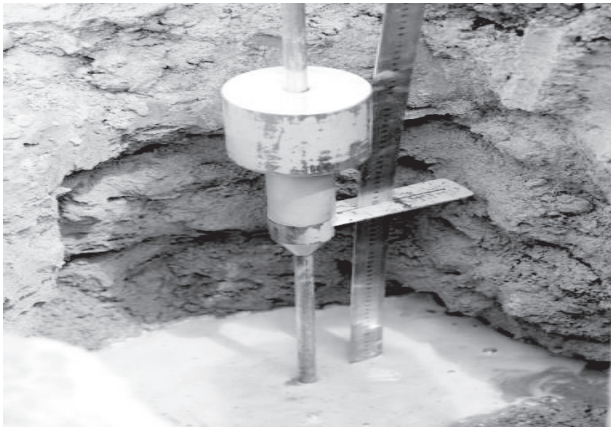
Figure 13. Subgrade layer saturated by water at Ranakharia Mosque

- . Implementing enhanced subgrade stabilization techniques in vulnerable sections.
- . Improving drainage systems to manage moisture levels and reduce subgrade saturation.
- . Conducting regular monitoring and maintenance to identify early signs of pavement distress.

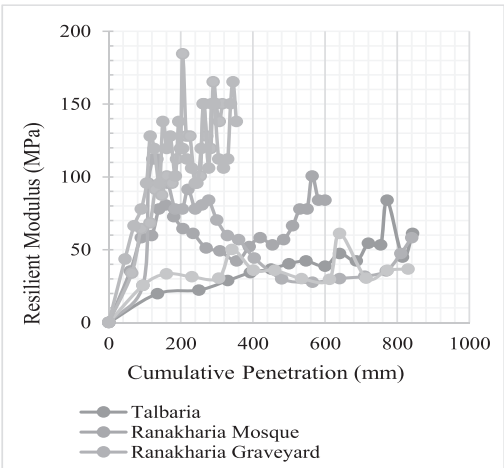
Using the DCP test results, we prepared a resilient modulus vs. subgrade depth graph for the two different highway sections, with the comparison shown in Figures 14 and 15. As illustrated in Figure 14, in the Trimohini to Baromile Chadgram section of the Rajshahi-Kushtia highway, the subgrade soil in Talbaria Kadamtola and Bahalbaria Bazar exhibited significantly reduced resilience. In these locations, the resilient modulus slightly increased with subgrade depth, reaching a maximum value between 600mm and 800mm. In the subsoil of Ranakharia mosque and Ranakharia graveyard, the resilient modulus displayed a similar pattern: it initially increased, then suddenly dropped, before increasing to a maximum value at greater depths. Conversely, in the Madhupur to Pabna terminal section (Figure 15), the resilient modulus increased rapidly before 100mm depth, reached its maximum value, and then gradually decreased with depth.

Figure 14. Resilient Modulus at Trimohoni-Baromile road section

The primary difference between the two highway sections was that in the Trimohini to Baromile section, the resilient modulus increased with greater depth of penetration, whereas in the Pabna bus terminal to Madhupur section, it decreased with depth. It was concluded that the Trimohini to Baromile highway section exhibited poor resistance to dynamic vehicular loads, leading to regular depressions and damage to the pavements. However, there was an exception in the Khadimpur-Athmile Bazar and Baromile regions, which showed superior resilient modulus values due to their deviation from cohesive behavior and lower moisture content. Figure 15 shows significant  $M_R$  variation within the same highway section. Some areas had higher  $M_R$  values, while others were significantly lower. Pavement performance was influenced by the weakest subgrade sections, leading to localized failures even if the road's overall condition appears good. In the Trimohini to Baromile Chadgram section, locations like Talbaria Kadamtola and Bahalbaria Bazar exhibited reduced resilience, causing regular depressions and damage. These failures can cause overall pavement deterioration over time. It is to be agreed that drawing a direct correlation between subgrade strength and failure intensity at different points is crucial. The observations indicated that weaker subgrade areas are more susceptible to dynamic vehicular loads, contributing to localized failures. While Khadimpur-Athmile Bazar and Baromile regions showed superior resilient modulus

The resilient modulus of the subgrade soil, a key indicator of its stiffness and load-bearing capacity, was analyzed using DCP tests and correlated with CBR values. In the Trimohini to Baromile section, the  $M_R$  varied significantly across different locations, influenced by factors like moisture content and subgrade depth. Locations such as Talbaria-Kadamtola and Bahalbaria Bazar showed lower  $M_R$  values, indicating poorer subgrade conditions prone to pavement failures. In contrast, the Madhupur to Pabna section exhibited higher and more consistent  $M_R$  values, reflecting superior subgrade performance.

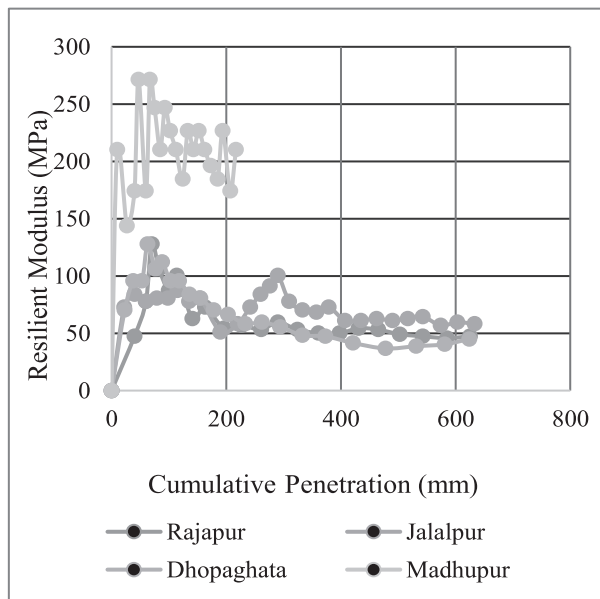
**Figure 15.** Resilient Modulus Data of Madhupur to Pabna Bus Terminal Road section.

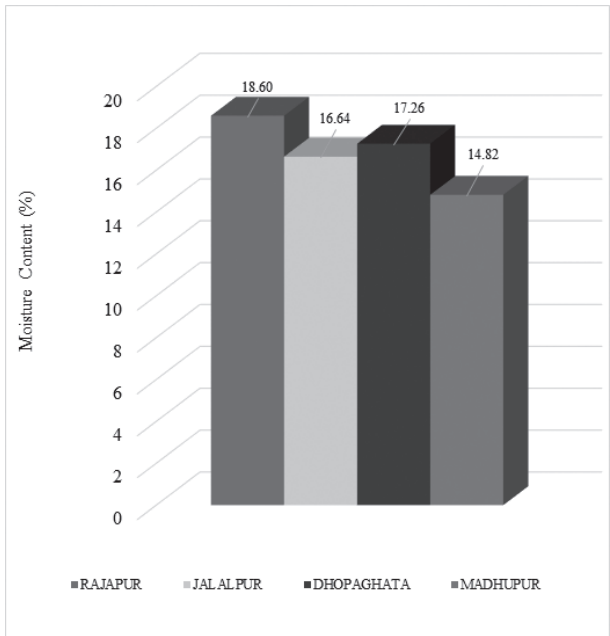
the Pabna Bus Terminal to Madhupur section was normal, as shown in Figure 17, with no nearby rivers or water sources affecting the subgrade.

Figure 17. Moisture Content chart at Pabna bus terminal-Madhupur section.
