# An Analysis of Seismic Risk for the Building Stocks in the Sylhet City Corporation, Sylhet, Bangladesh: A Case Study on Ward No. 1

Bangladesh is one of the most earthquake-prone countries in the world because of the difference in energy between the Indian and Burma plates. Frequent earthquakes could lead to massive loss of property and destruction. This study aims to determine the seismic risk of building stocks in Sylhet City Corporation (SCC). Amongst 28 wards, Ward No. 1 was selected, as it is one of the preferable residential areas and has almost 2143 buildings. By following Sloven's formula (1960), 320 buildings were randomly selected. The level-I observational survey is conducted with a checklist to see the status of the buildings. General information was analyzed through descriptive statistics. The Modified Turkish Method, proposed by Socuoglu and Yazgan, was followed to find out the building's performance score. A fragility curve calibrated for 475 years, given by Alam et al. 2018, was followed to detect the probable damage number of buildings. It is found that one-story buildings are most prominent here (58.75%). Almost 40% of the construction period is under 20 years (

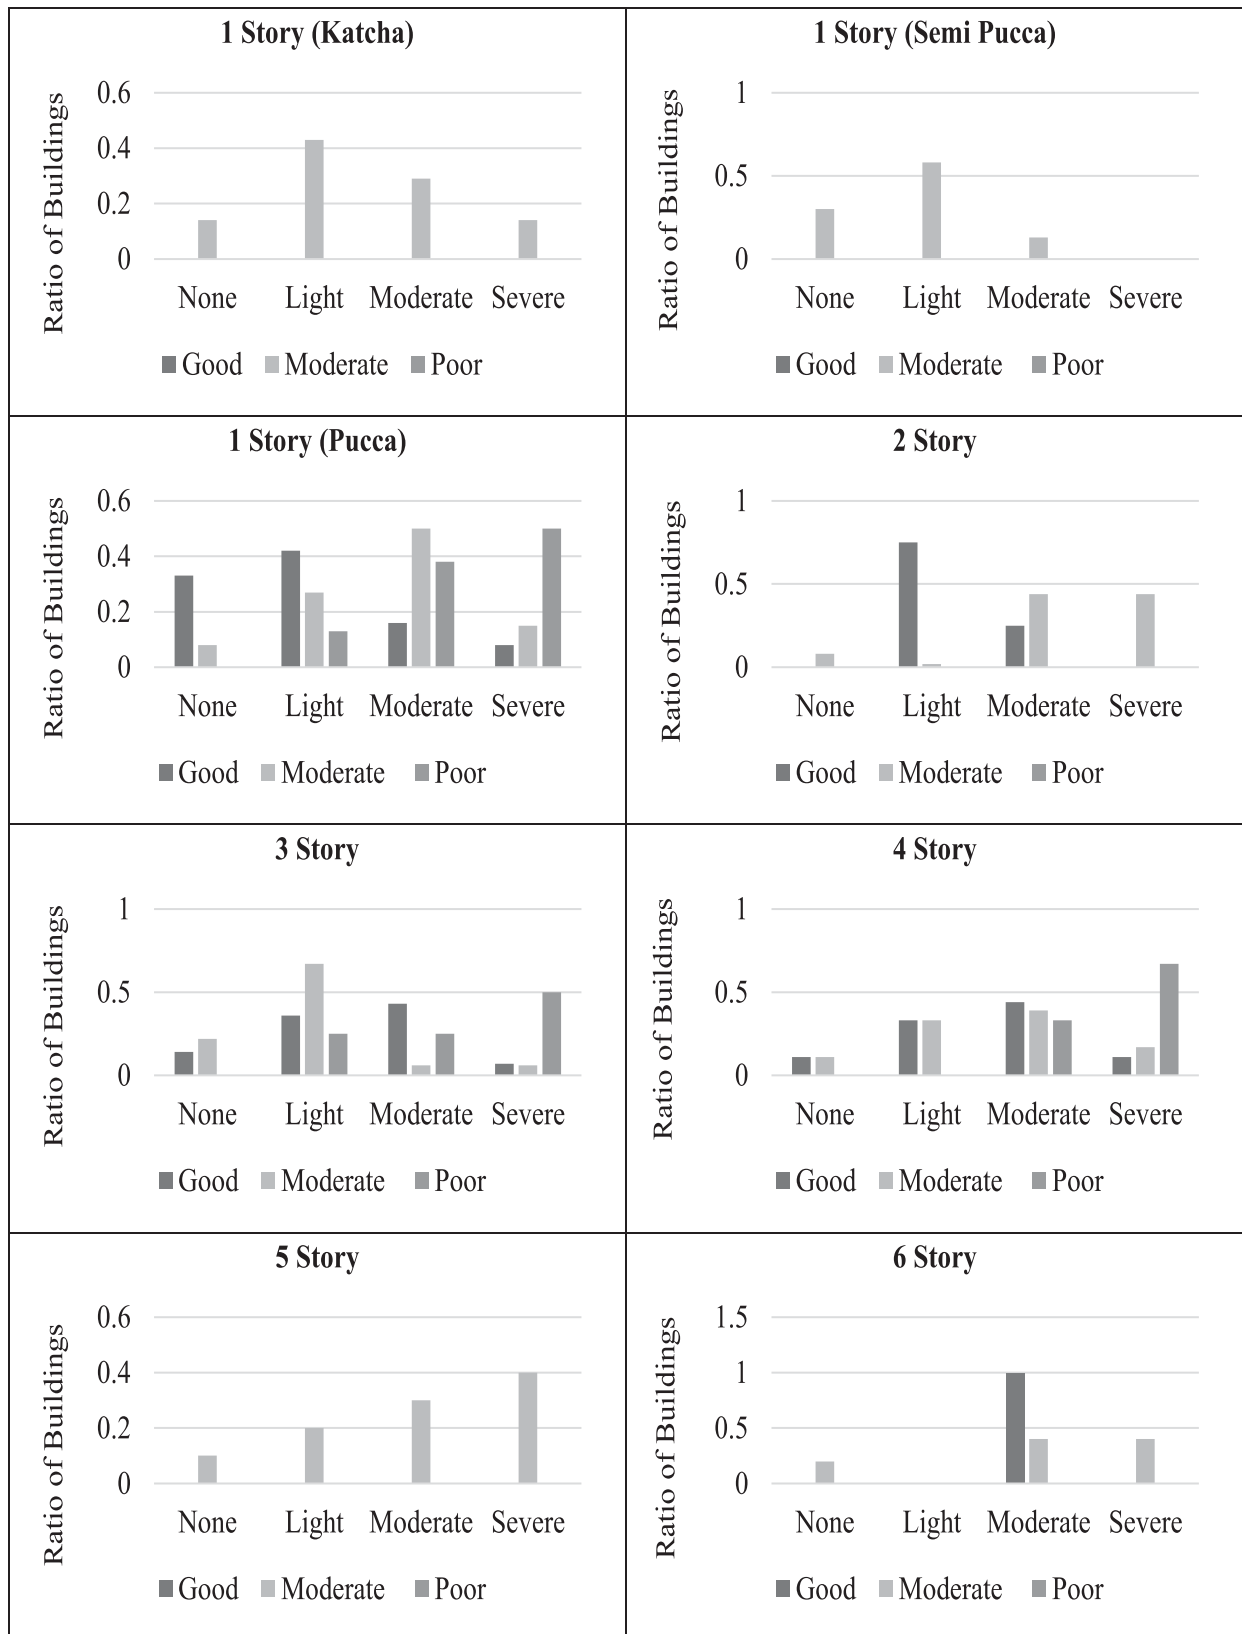
Fig. 13 : Normalized wrt. Presence of Apparent Building Quality

The quality classification of 320 surveyed buildings revealed that 41 are good, 264 are moderate, and 15 are poor (Figure 13). From the observation survey, it is determined that moderate or severely damaged buildings have lesser quality than the others. It is especially true for 3 and 4 stories.

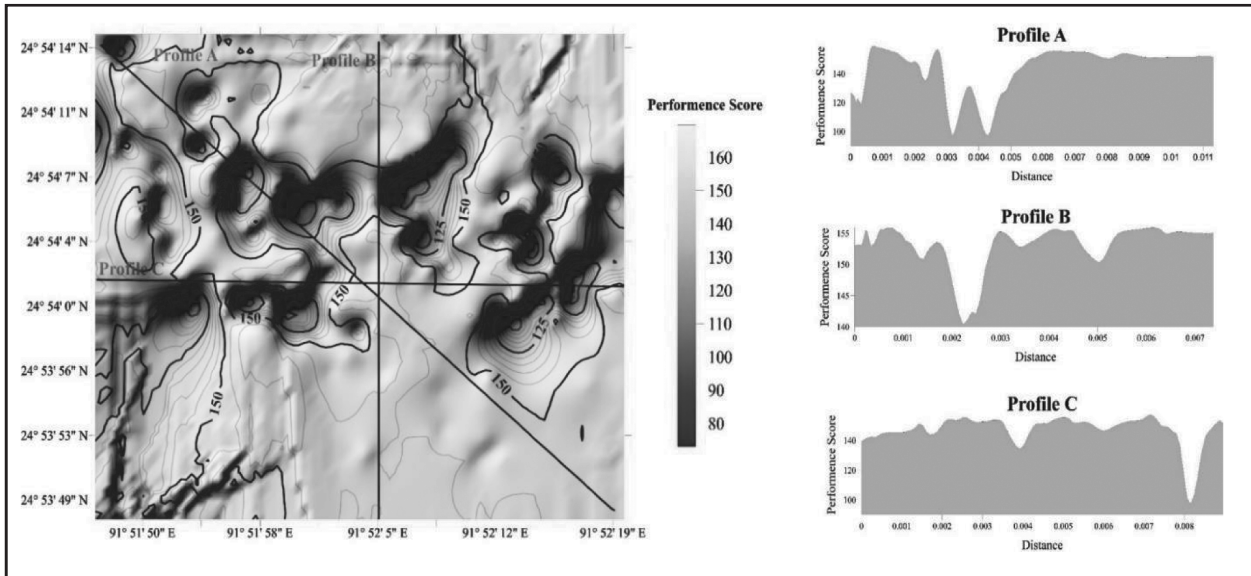
Fig. 16 : Cross Section Profile of Buildings Performance Score

The cross-section profile depicted a high-weighted buildings performance score, indicating this zone's low seismic risk (Figure 16).
